ST LAWRENCE CHURCH, BERKSHIRE– Church Monument

CLIVEDEN CONSERVATION WORKSHOP LTD

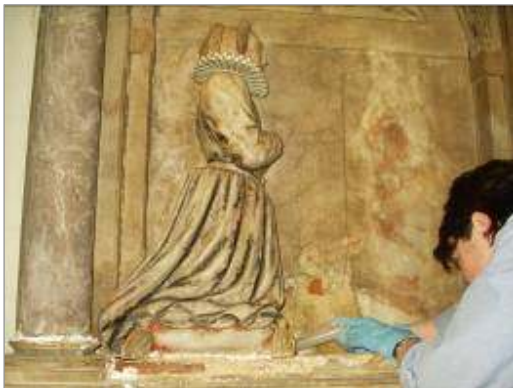
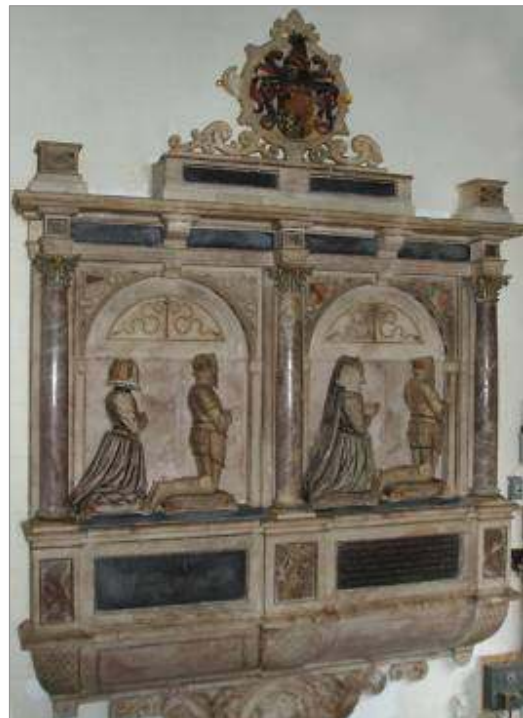
A large late 16th century wall monument to Sir Henry Neville in contrasting shades of alabaster, embellished with polychrome and gilding. The monument had experienced structural movement mainly to the top architrave and pediment. It was heavily soiled with probably 100 years of surface dirt. Many small loose fragments of broken stone were also discovered sitting on the ledges of the monument.

The monument was recorded before any works commenced. The top section was then carefully dismantled after removing all the iron cramps and re-assembled using high-grade stainless steel cramps. The sculptured elements were removed to the workshop and subsequently returned after cleaning and minor repairs and the remaining elements were also cleaned in situ. For further protection the whole monument was then given a light microcrystalline wax.
